Manhole Inspection Summary

Manhole # S41WW_013MH

Insp Date: **2/23/07 10:27 AM**

Location Address: **1302 LOCH RAVEN RD**

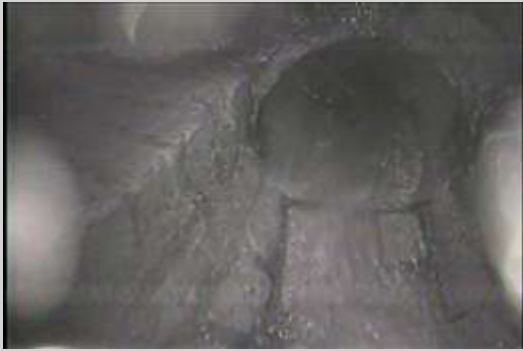
10 in. Circular Gravity Sewer Pipe Out @ 12 O'Clock

Pipe Material: **Clay** ☐ Pipe Lined

Invert Depth: **17.40** (ft.) Flow Characteristics: **Slow**

Deposits: ☒ None ☐ Mud ☐ Sludge ☐ Debris ☐ Grease

Infiltration: **None** Pipe Seal Cond: **Unknown**

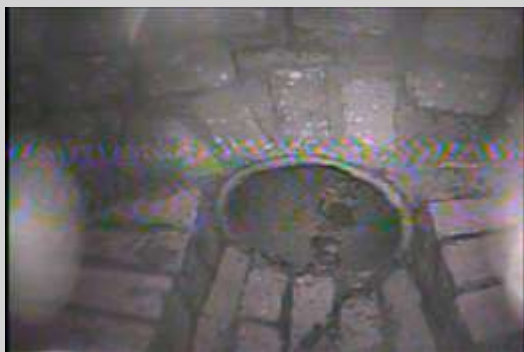
8 in. Circular Gravity Sewer

Pipe Material: **Clay** ☐ Pipe Lined

Infiltration: **None**
